Test Report

Report No.: UNIB20040203DR-01

3. Test Item: IPX4

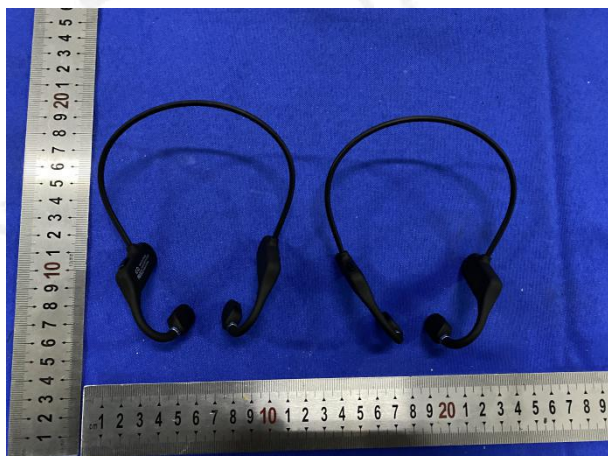
<p>Before the testing</p>	<p>In testing</p>

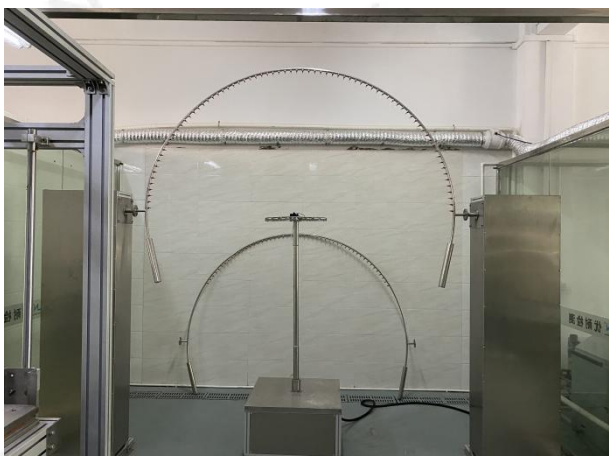
1. Angle Direction: spray ± 180° from vertical;
2. Per hole flow: 0.07 L/min;
3. Duration of test: 10 min;
4. Distance from nozzle to enclosure surface: 200mm.

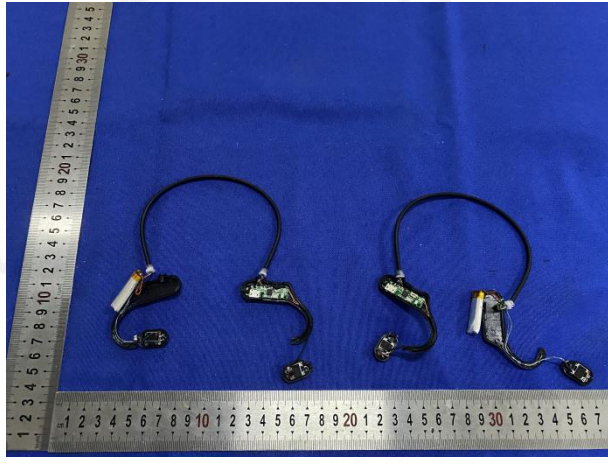
Sample number	Test result	Determine
1#	After the test, there was no trace of water in the shell.	Pass
2#	After the test, there was no trace of water in the shell.	Pass

<p>/</p>
<p>After the test</p>	<p>/</p>
